DC-17-02998

SUZANNE CALLAWAY-DAVIS

AMAZON.COM LLC, OLADAYA  
ANIPOLE, INPAX SHIPPING  
SOLUTIONS INC., AND INSS, LLC*Defendants*§  
§  
§  
§  
§  
§  
§  
§  
§

**PLAINTIFF SUZANNE CALLAWAY-DAVIS' ORIGINAL PETITION**

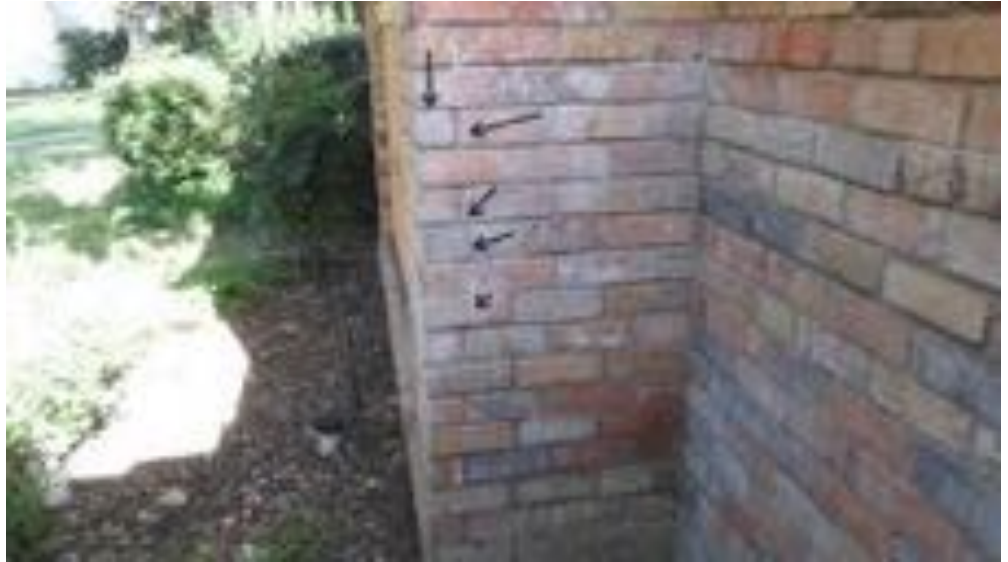
### 12 12-BRICK CRACKS AT INPACT SITE

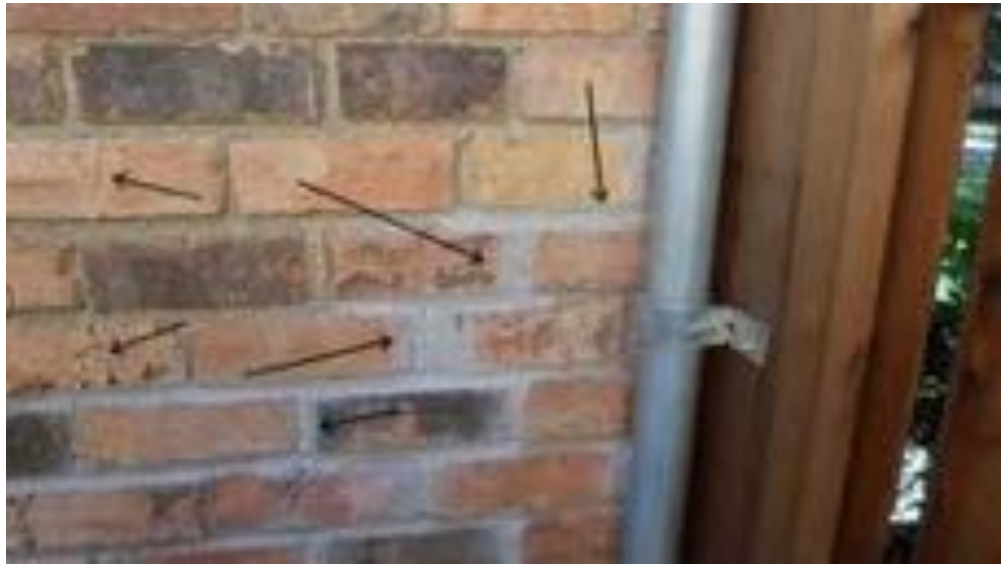
24 25-CRACKS IN THE BRICK  
CRACKING AT LEFT SIDE

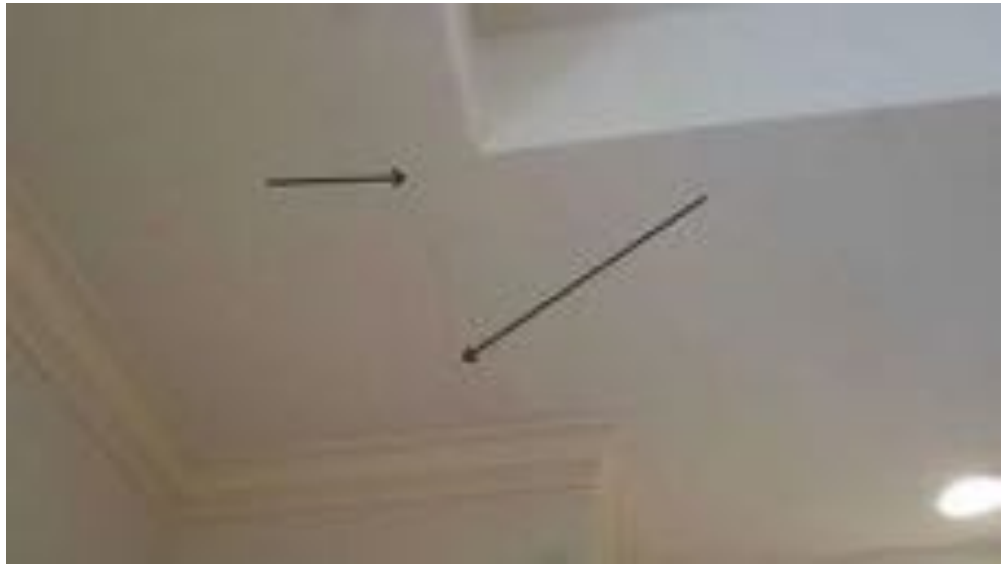
34 36-WALL CRACKS FROM  
IMPACT DINING ROOM

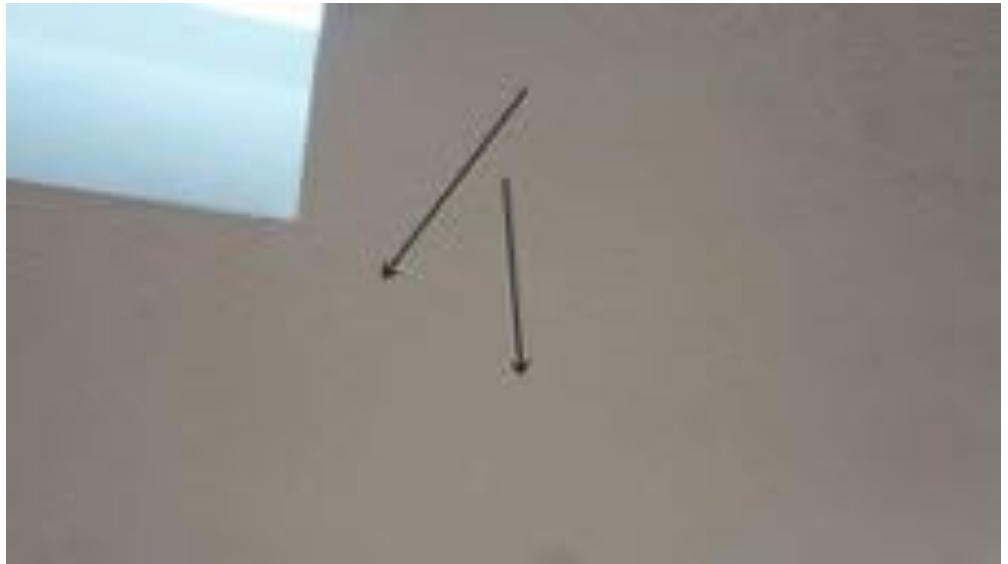
- 43 46-CEILING CRACK AT  
KITCHEN SKYLIGHT  
Date Taken: 8/14/2012  
Taken By: Tony Sherriff

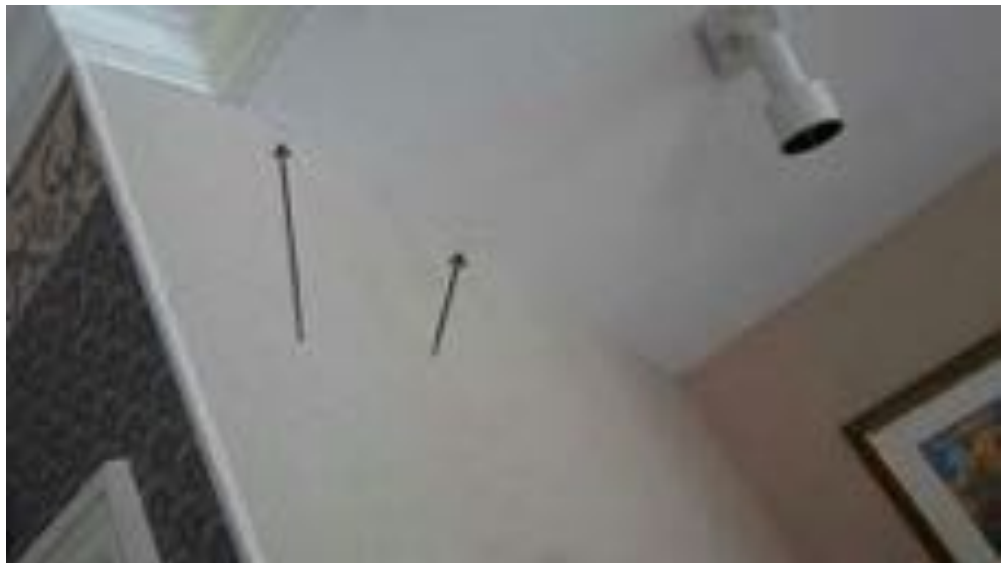
- 44 47-DRYWALL CRACKS AT  
KITCHEN  
Date Taken: 8/14/2012  
Taken By: Tony Sherriff

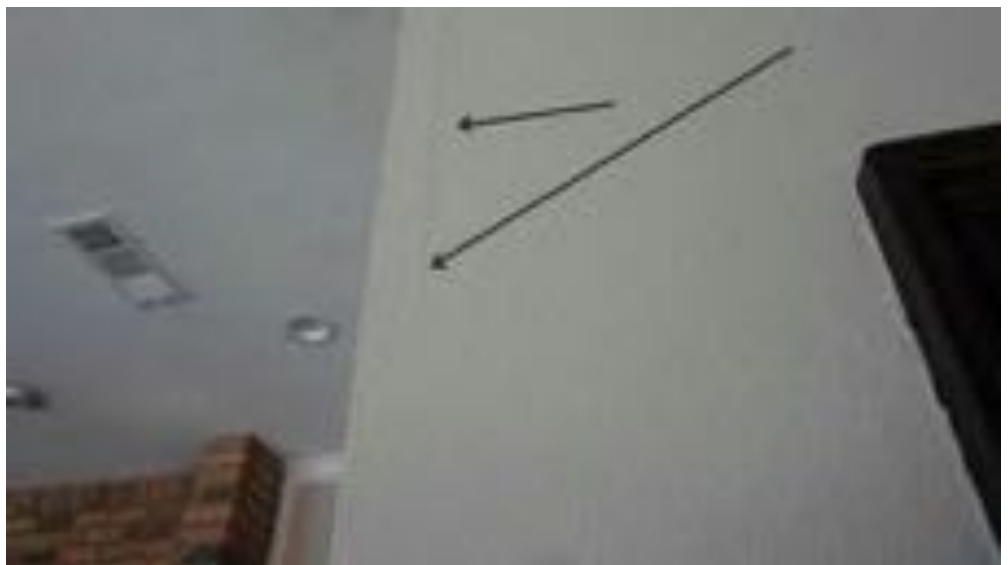
- 54 59-FOYER WALL CRACKS  
Date Taken: 8/14/2012  
Taken By: Tony Sherriff

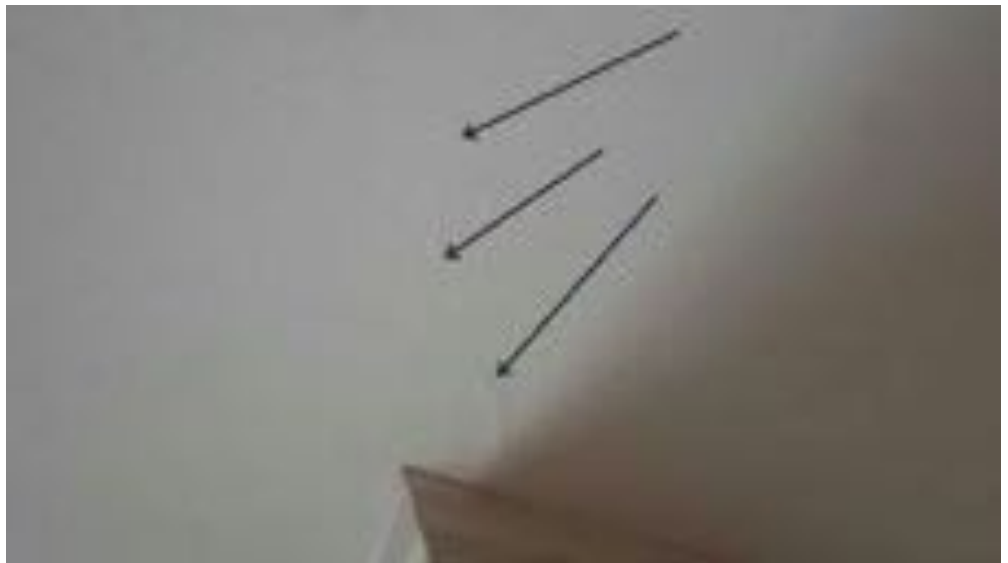
- 56 63-FOYER CEILING CRACKS  
Date Taken: 8/14/2012  
Taken By: Tony Sherriff

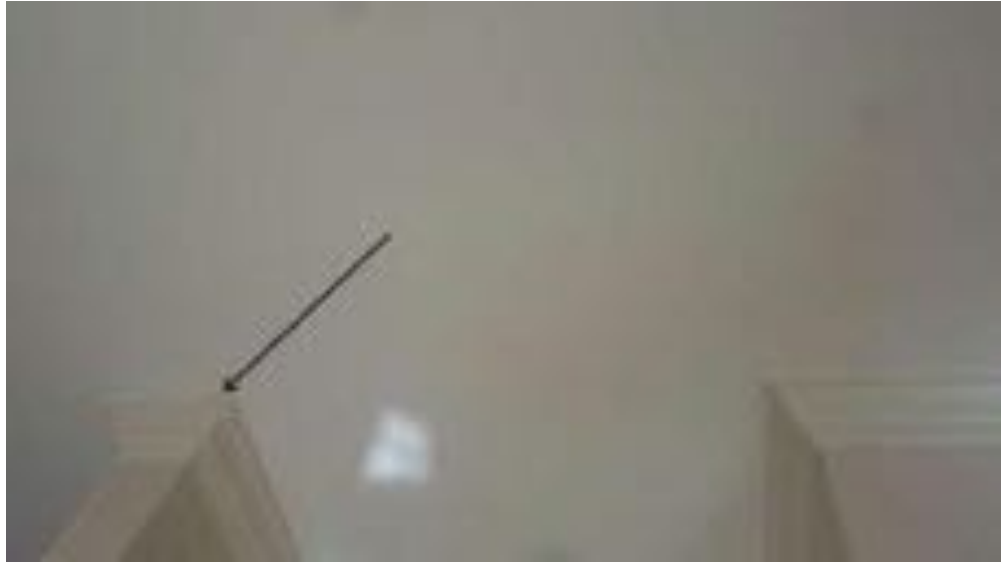
58 65-FOYER DRYWALL CEILING  
CRACK

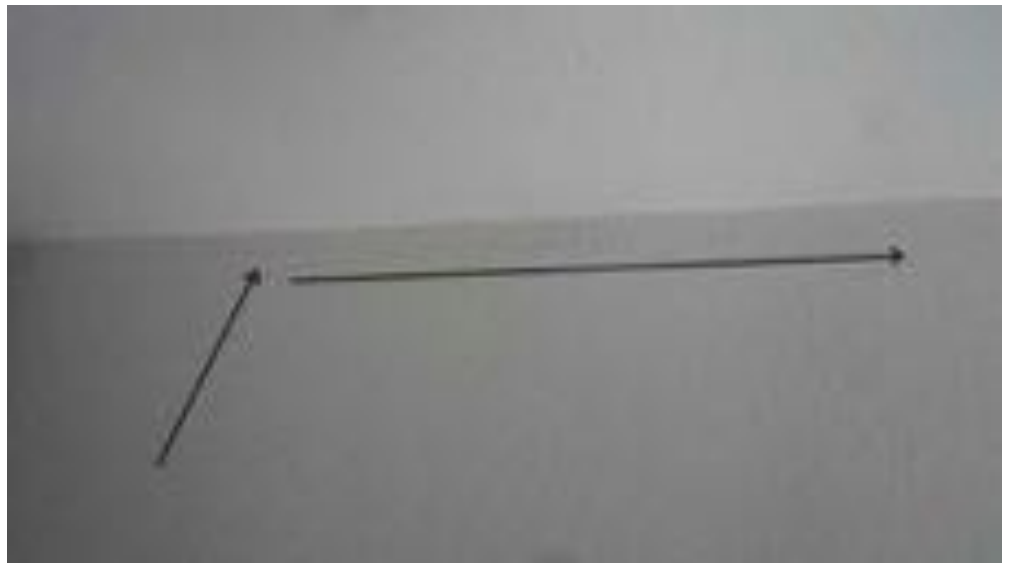
- 76 87-master bedroom drywall  
damage  
Date Taken: 8/14/2012  
Taken By: Tony Sherriff

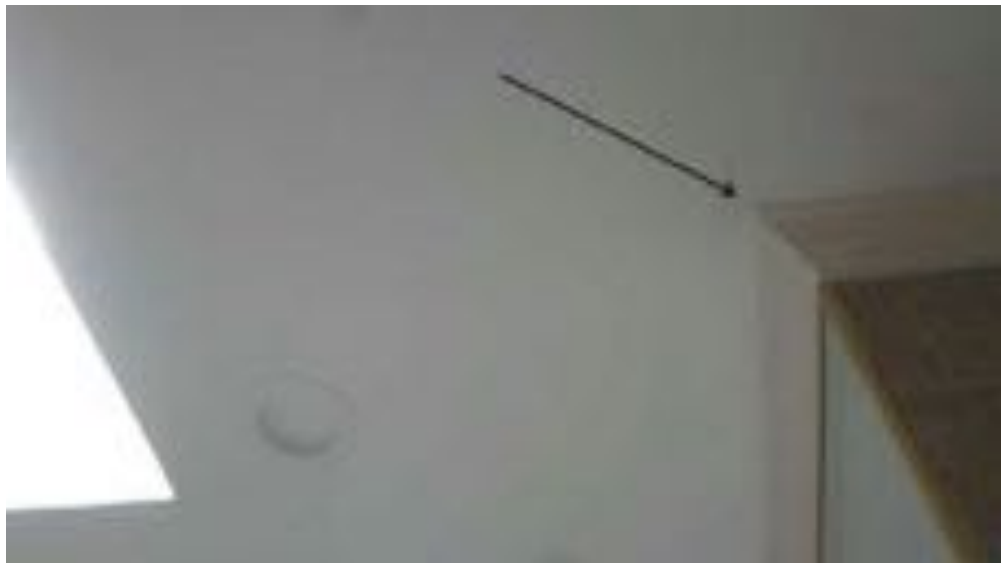
- 84 96-ceiling crack  
Date Taken: 8/14/2012  
Taken By: Tony Sherriff

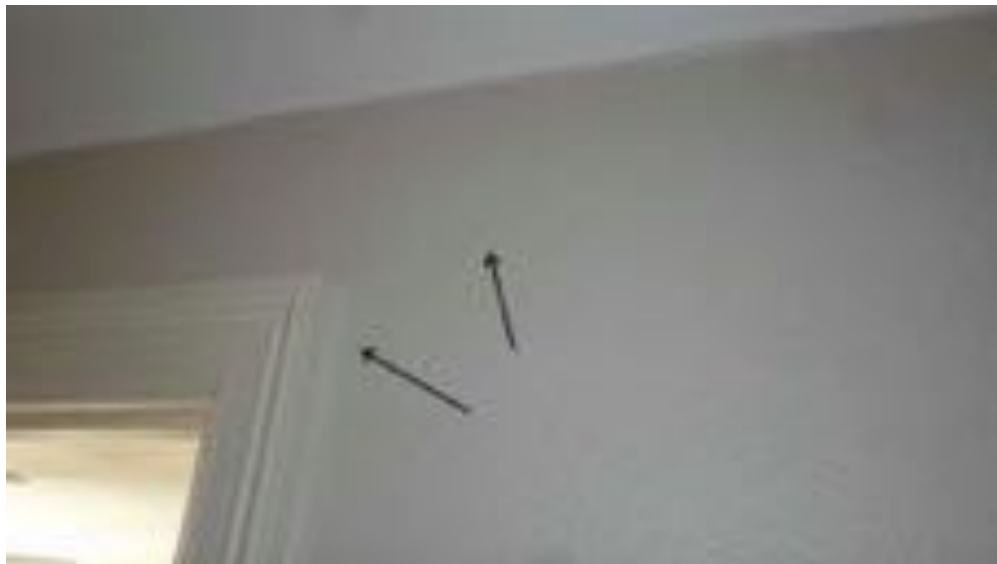
- 91 104-Drywall crack  
Date Taken: 8/14/2012  
Taken By: Tony Sherriff

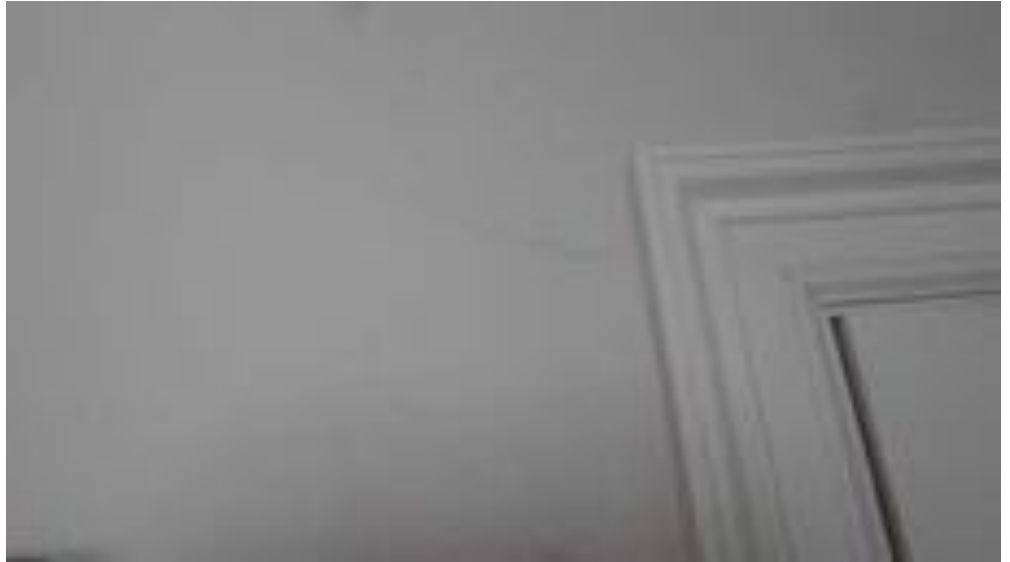
- 95 110-bedroom 2 wayy cracks  
Date Taken: 8/14/2012  
Taken By: Tony Sherriff

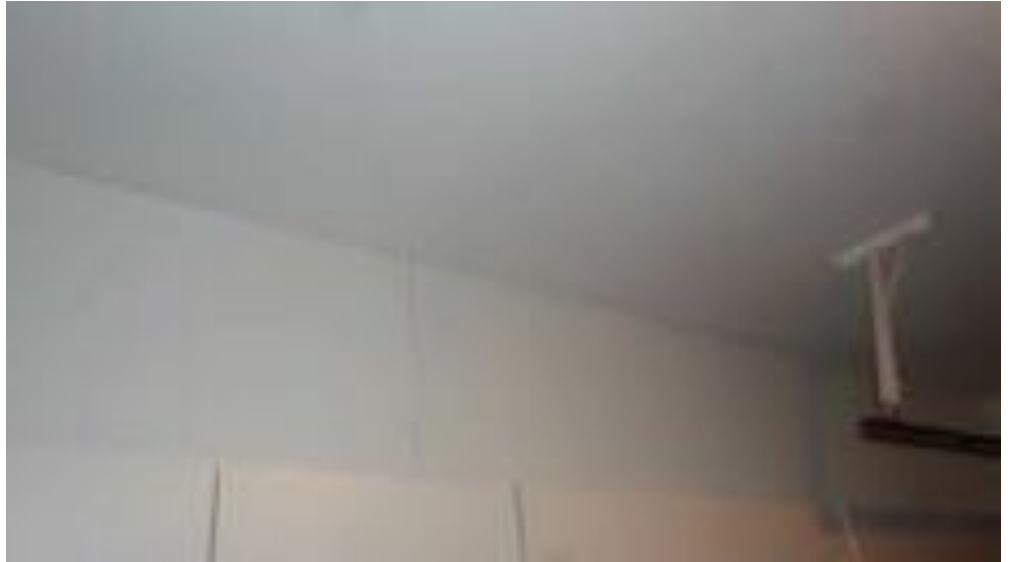
102 121-Garage drywall cracks

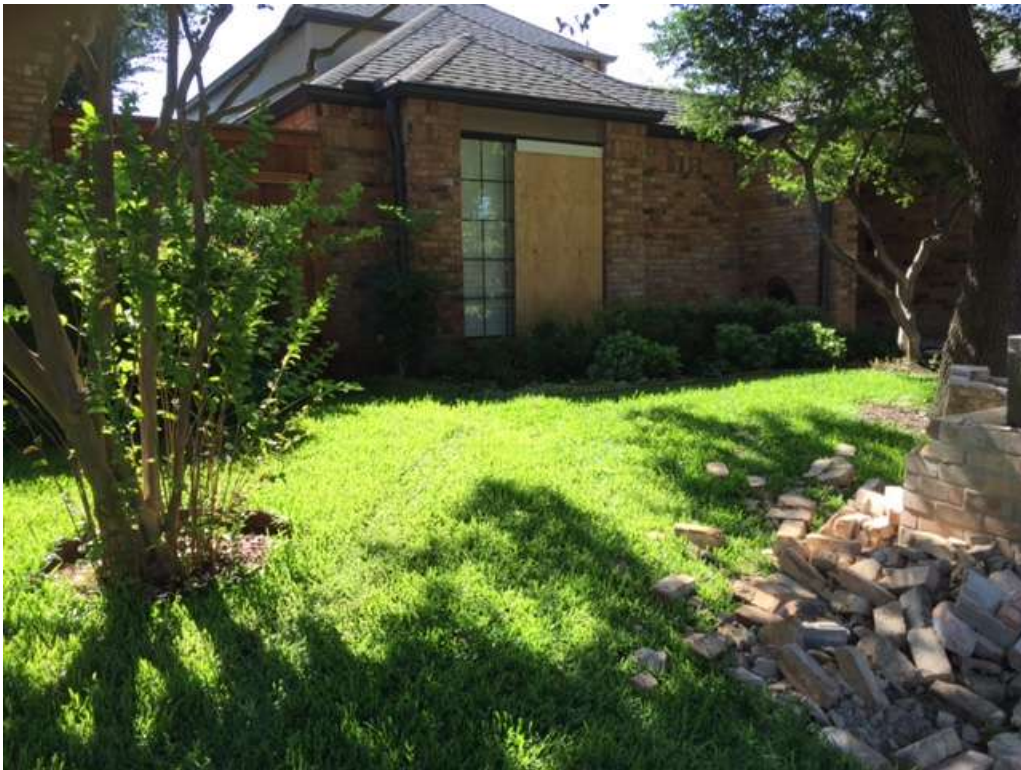
Photo 2: Front side view after the collision.

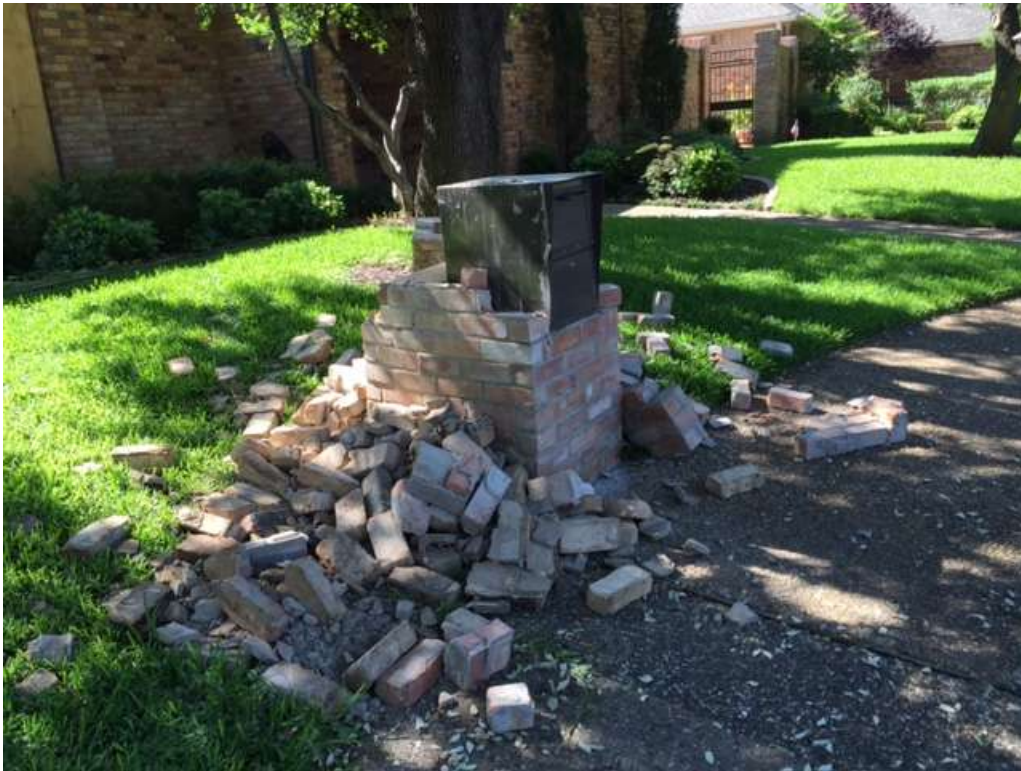
Photo 3: Brick mailboxes destroyed in vehicle pathway to home.

28. Mr. Becker recommended the re-building of the mailbox as well as repairing or replacing the outdoor sprinkler and lighting systems. Mr. Becker recommended replacing the exterior brick veneer and repairing the separated frieze board. Mr. Becker also recommended replacing the damaged window and frames. Further, Mr. Becker recommended the removal and replacement of the interior hardwood flooring as well as the interior sheetrock and trim.

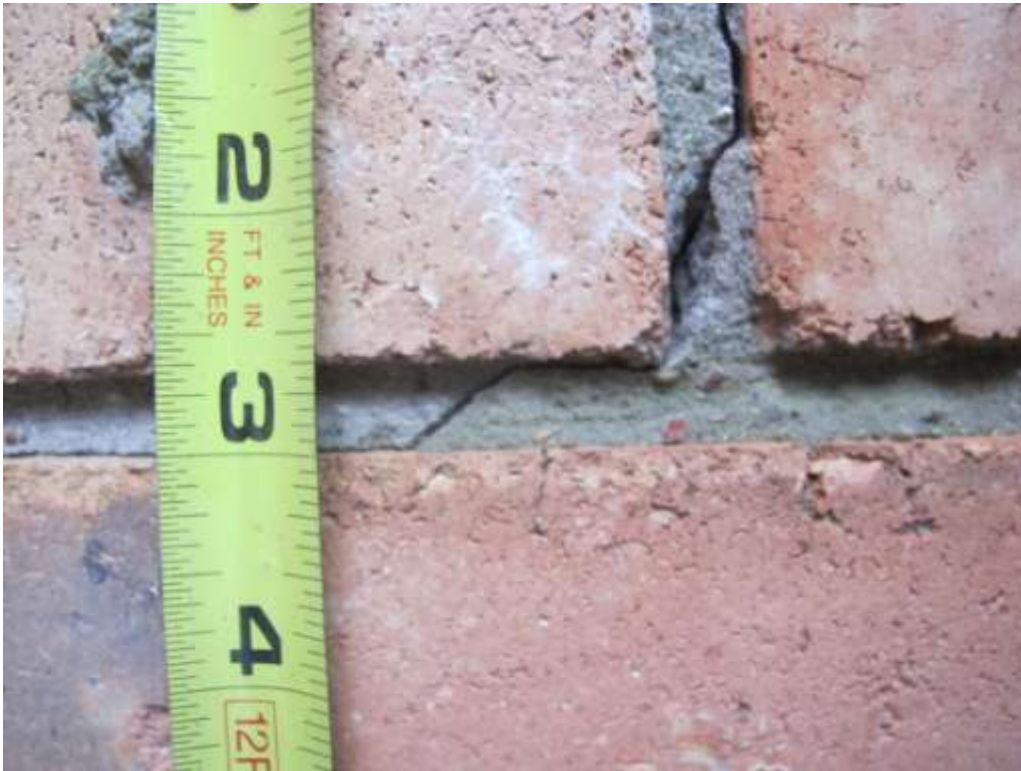
Photo 5: Fresh brick crack and mortar separations adjacent to impact area.

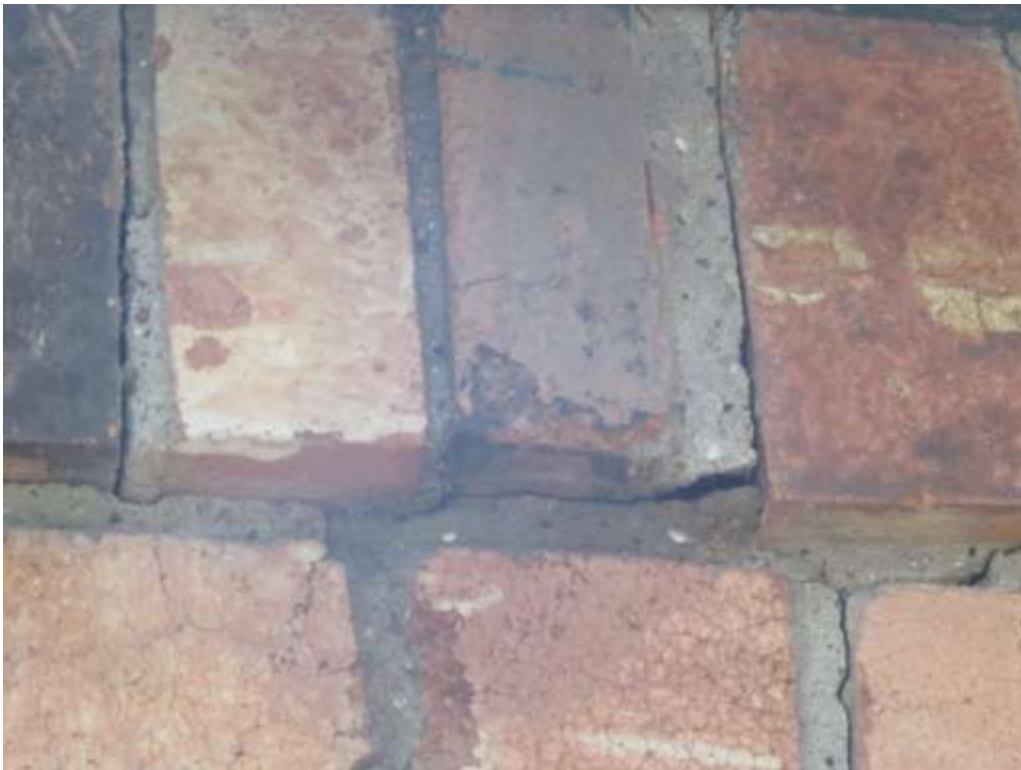
Photo 6: Fresh mortar separations adjacent to impact area.

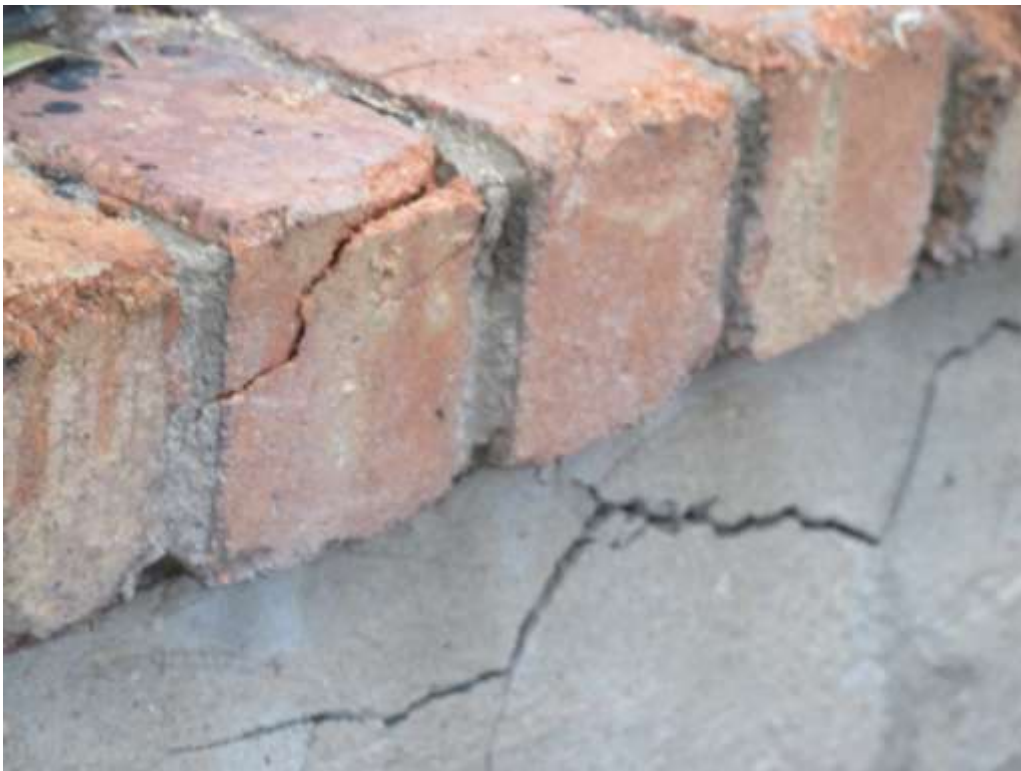
Photo 7: Fresh brick cracks and smear coat cracking at impact area.

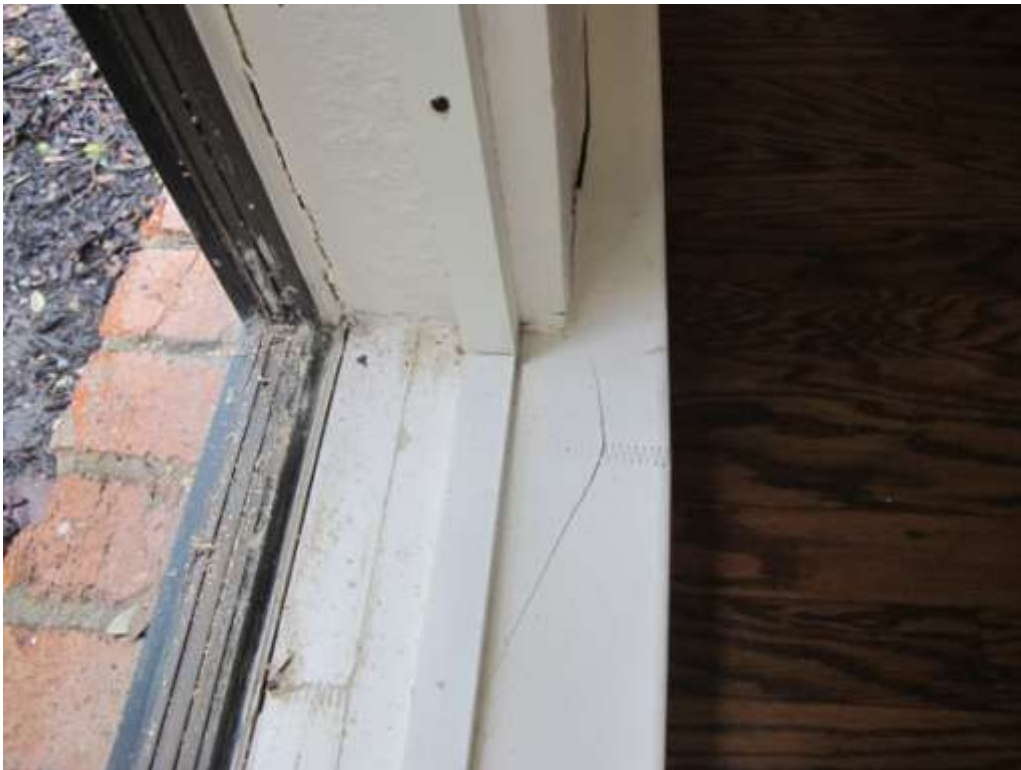
26. On September 26, 2016, Plaintiff retained Becker Engineering to inspect the Property and provide an engineering opinion. [Exhibit B]. Gregory Becker with Becker Engineering observed new cracks and separations in the brick veneer and junction of the frieze board. Although some areas outside the dining room were previously repaired, the vehicle collision showed a re-opening as well as a cracked foundation. The dining room window was destroyed and the glazing was separated from the frame. The window frame

was bowed, cracked, and separated. Mr. Becker observed that new cracks and separations were observed in the interior, consistent with the deflection of vibrations due to the impact of the vehicle, causing stress cracks and fractures. Mr. Becker also observed that the hardwood floor shows evidence of cupping due to the sprinkler water.

Photo 8: Window frame damage at impact area.

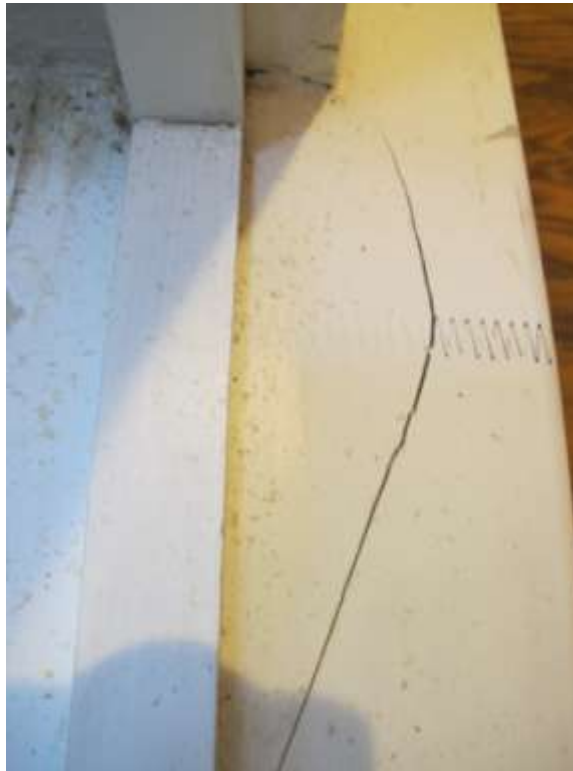
Photo 9: Closeup of interior window trim damage at impact area.

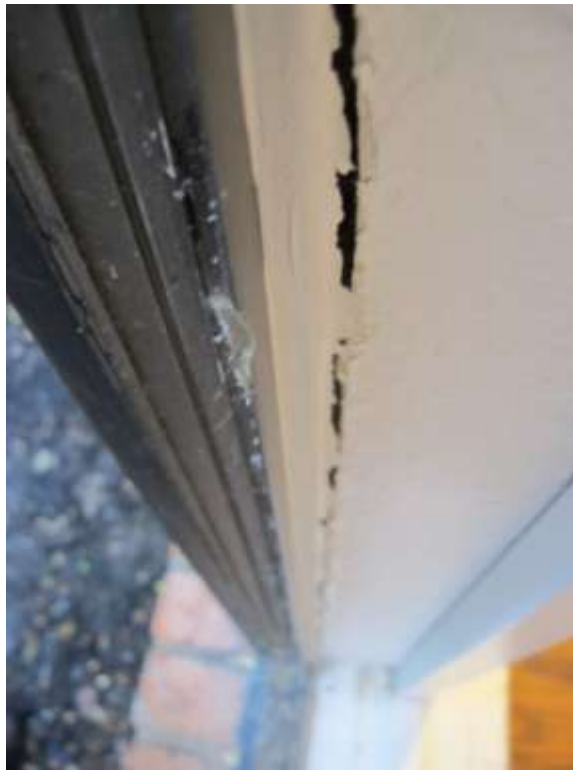
Photo 10: Close up of window frame damage at impact area.

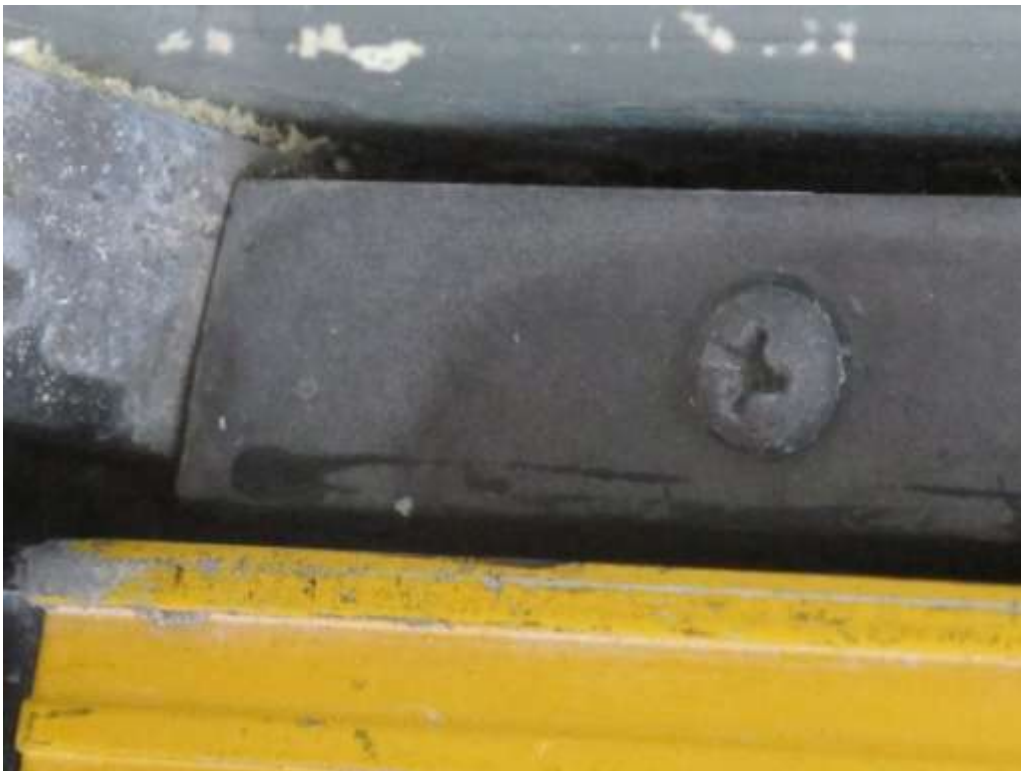
Photo 11: Remaining window frame separation from glazing at impact area.

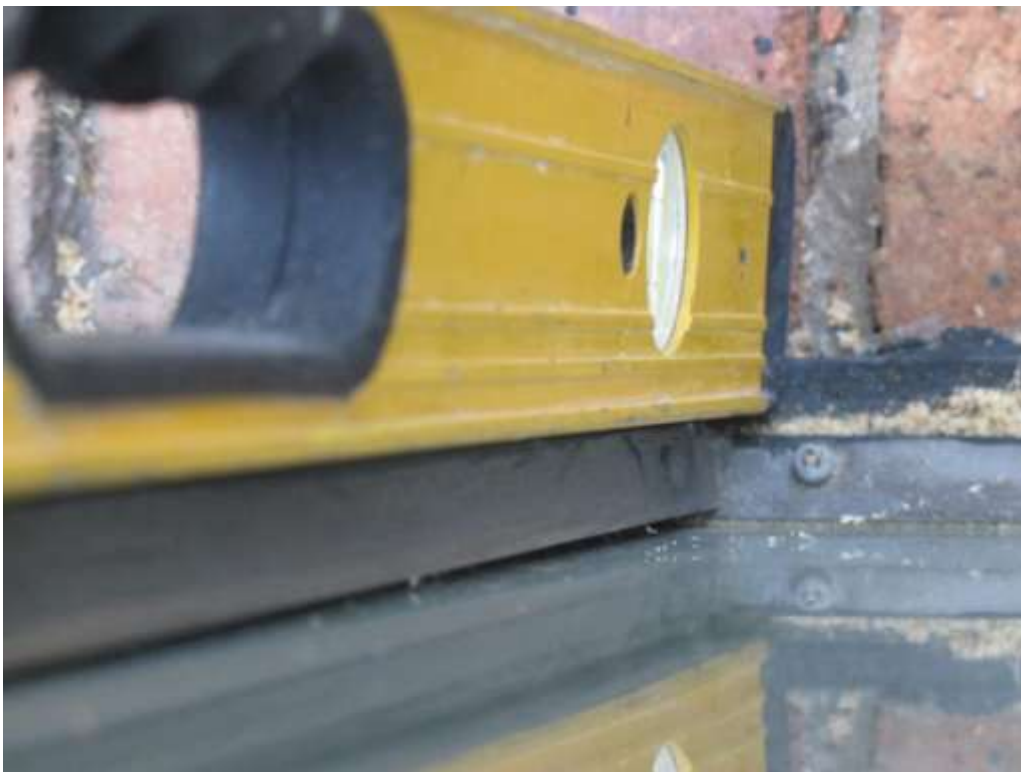
Photo 12: Remaining window frame separation from glazing at impact area.

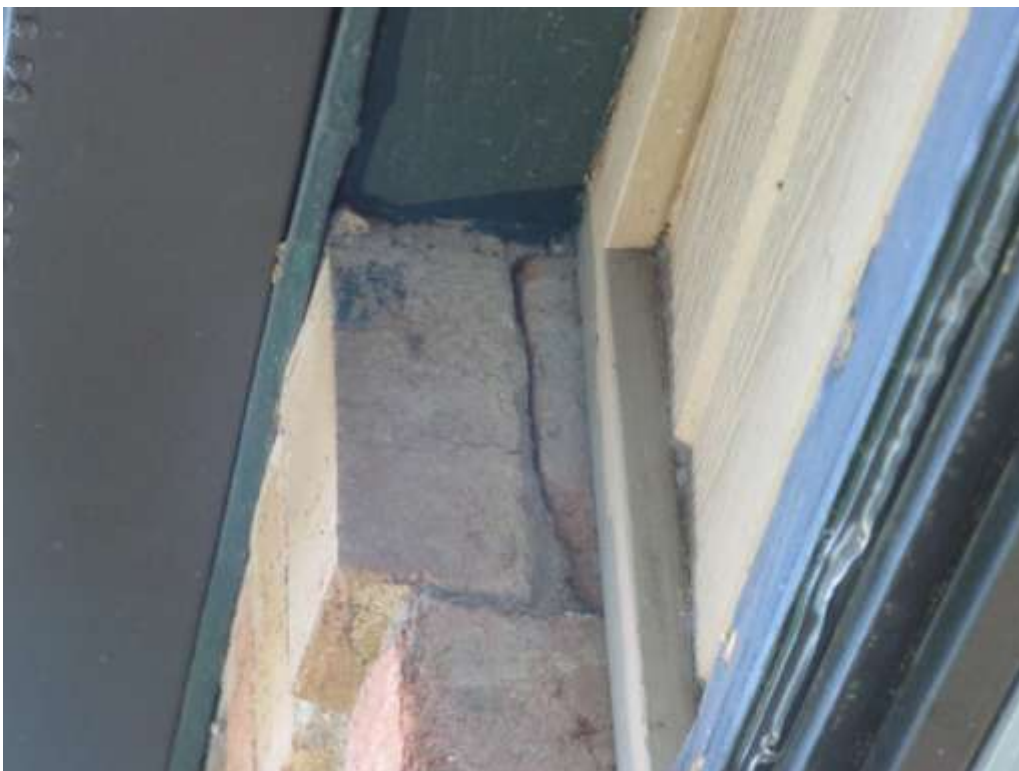
Photo 15: Separation of soldier brick near the impact area.

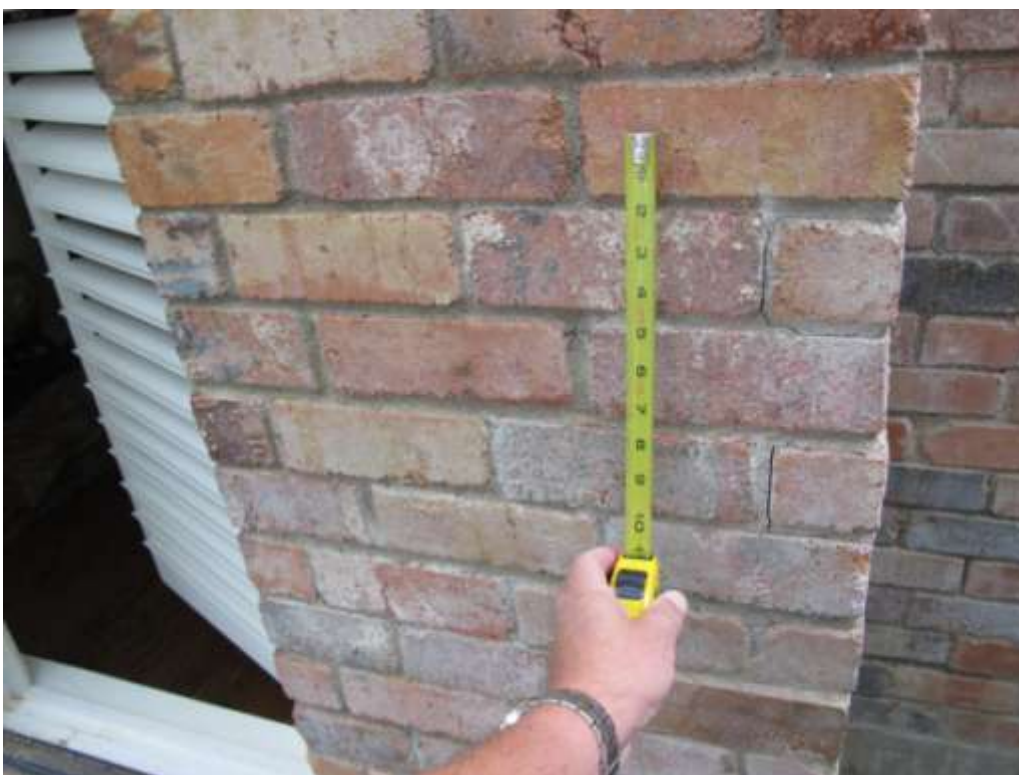
Photo 16: Brick veneer separations and cracks adjacent to the impact area.

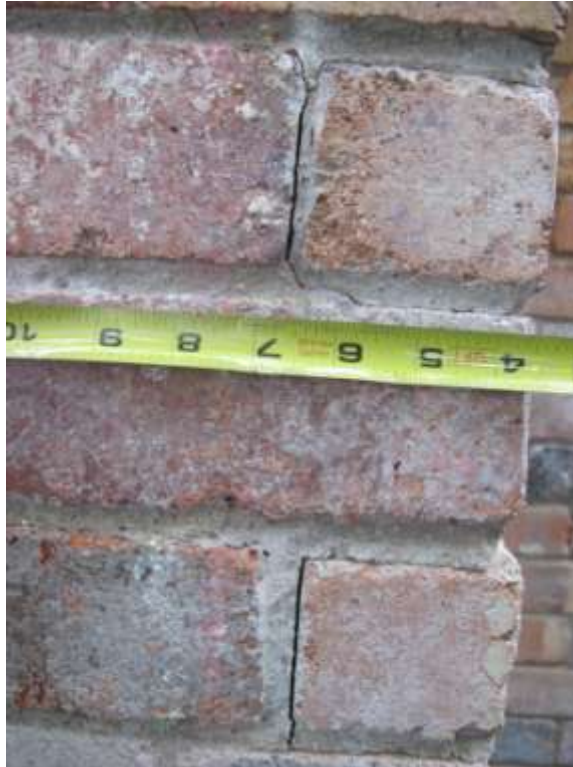
Photo 17: Close up of previous photo.

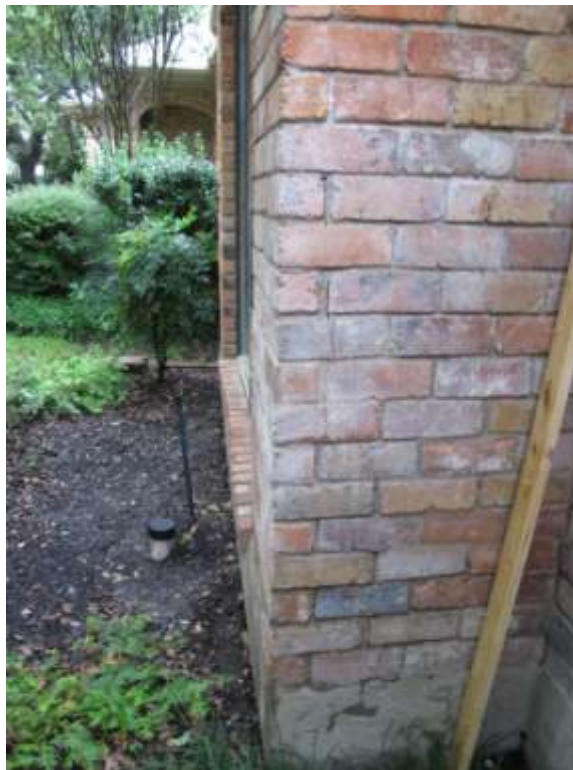
Photo 18: Brick veneer separations and cracks adjacent to the impact area.

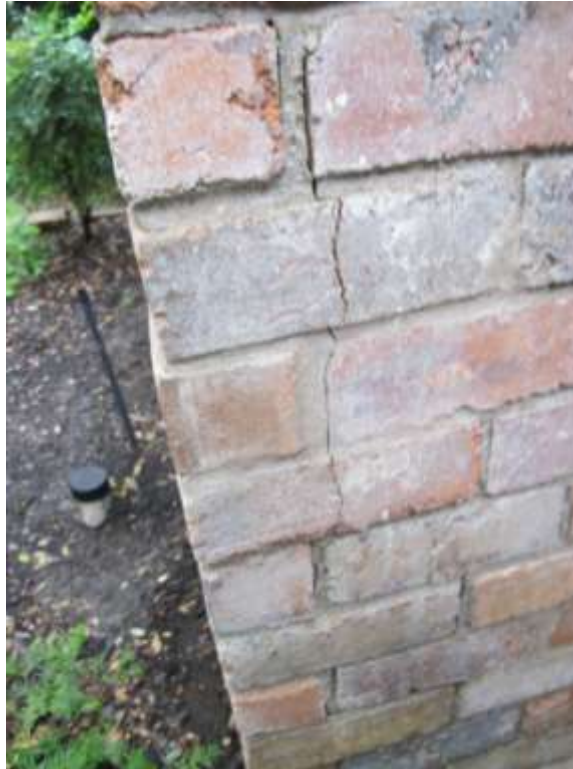
Photo 19: Brick veneer separations and cracks adjacent to the impact area.

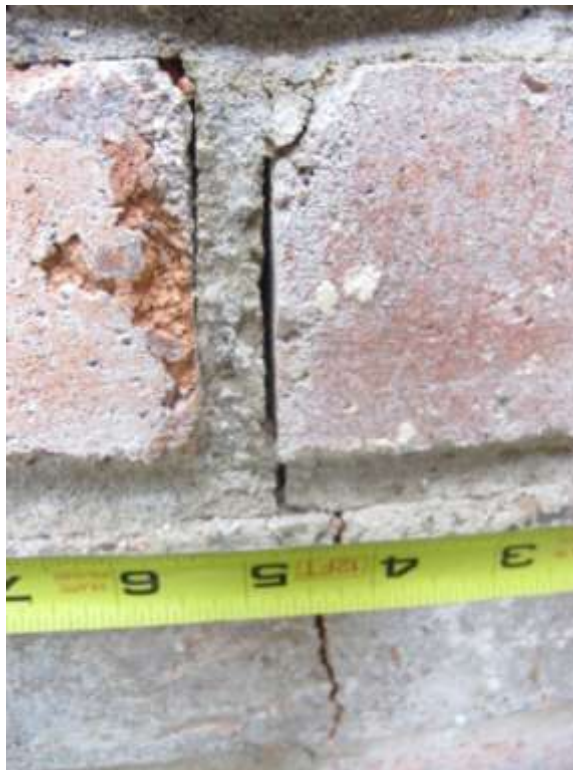
Photo 20: Close up of fresh separations and cracks in previous photos.

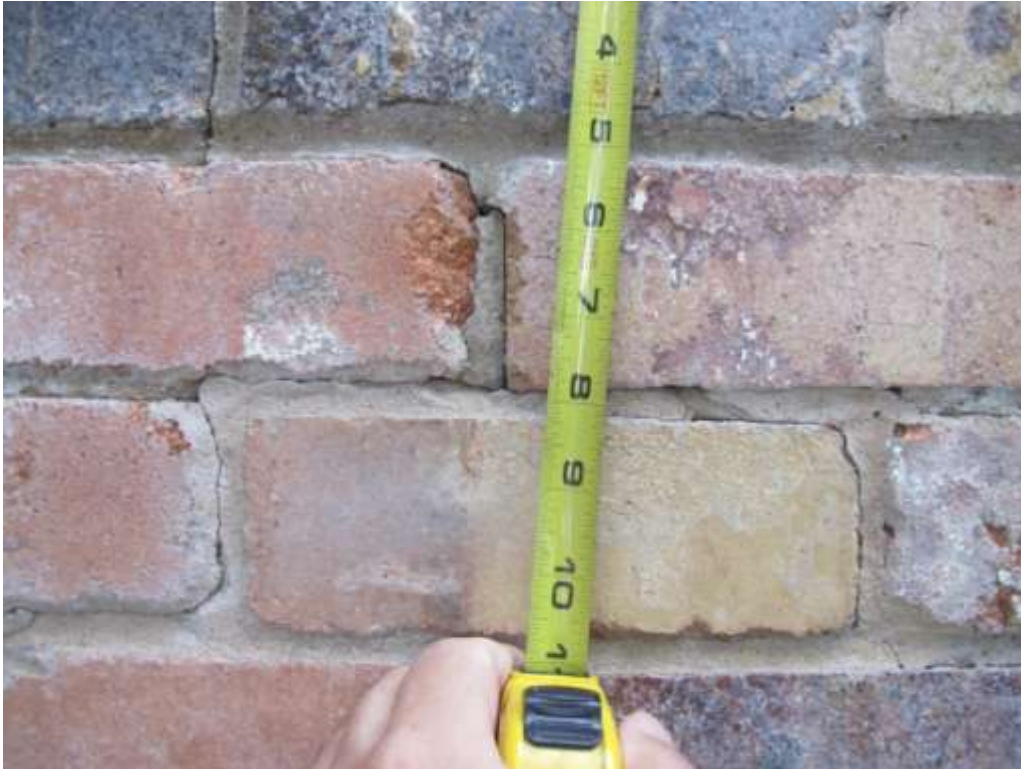
Photo 21: Brick veneer separations and cracks adjacent to the impact area.

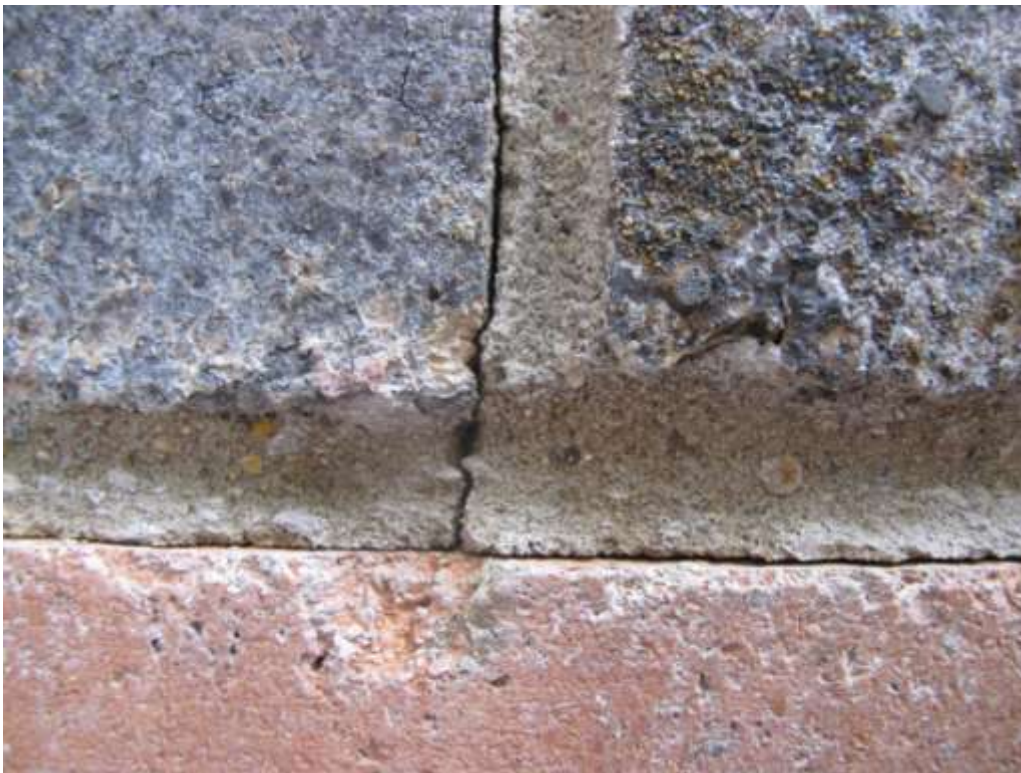
Photo 22: Close up of previous photo.

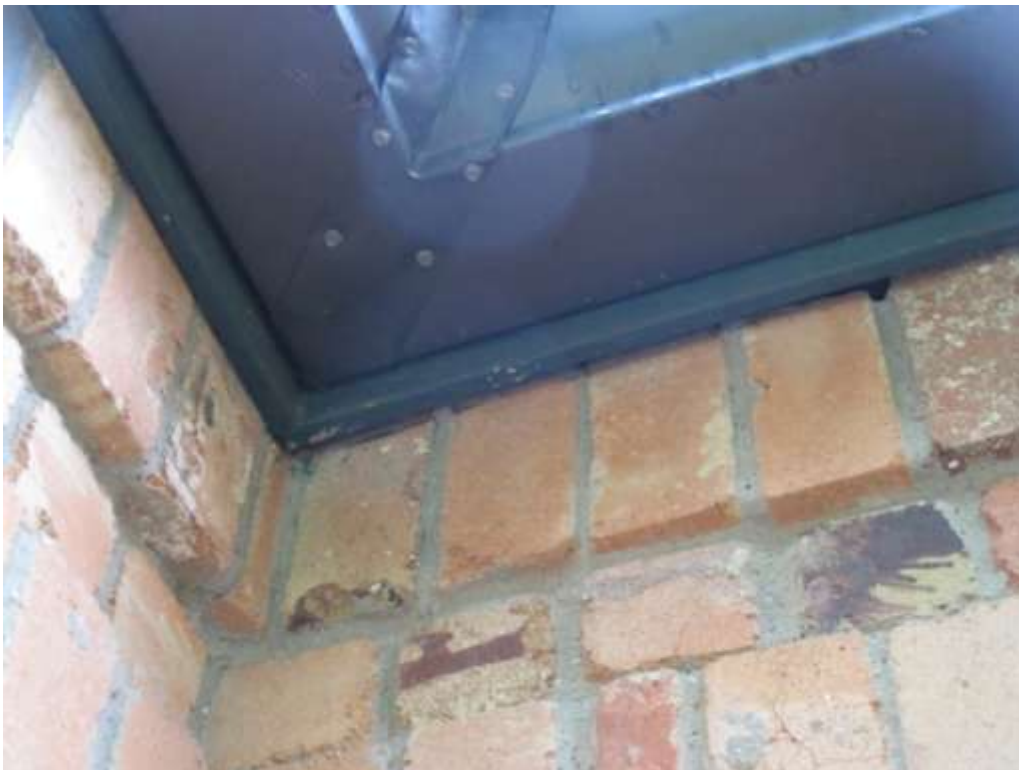
Photo 24: Separation of the frieze board and the soldier course adjacent to the impact area.

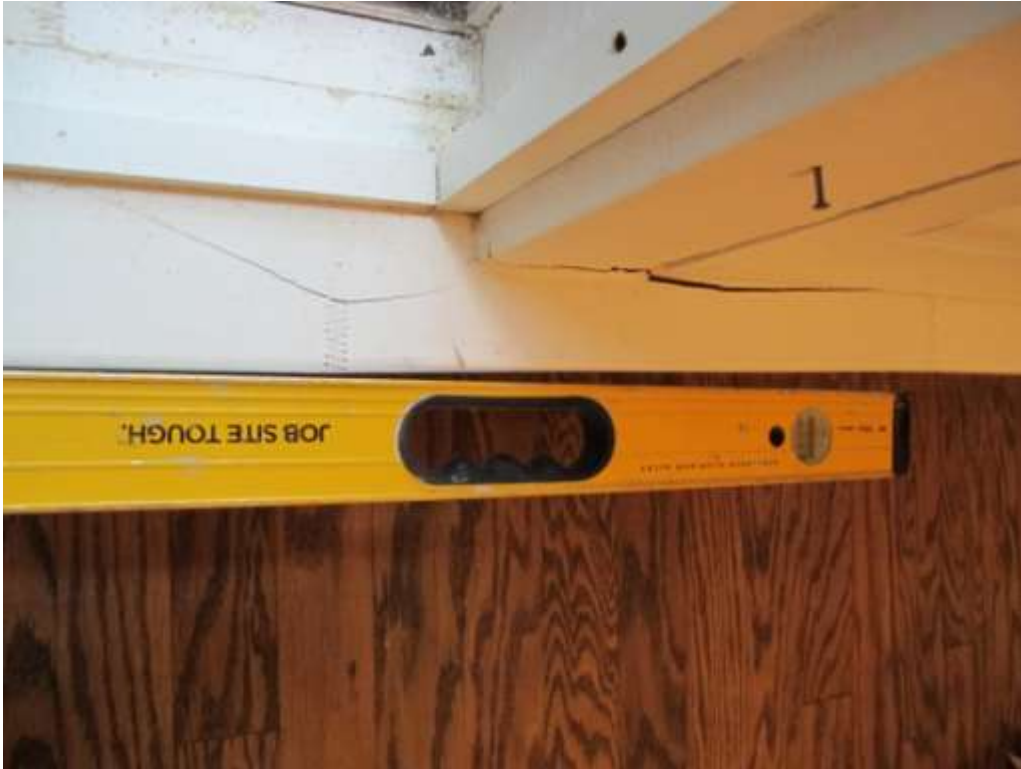
Photo 25: Existing bow or deflection of approximately 1/2" at the impact area framing.

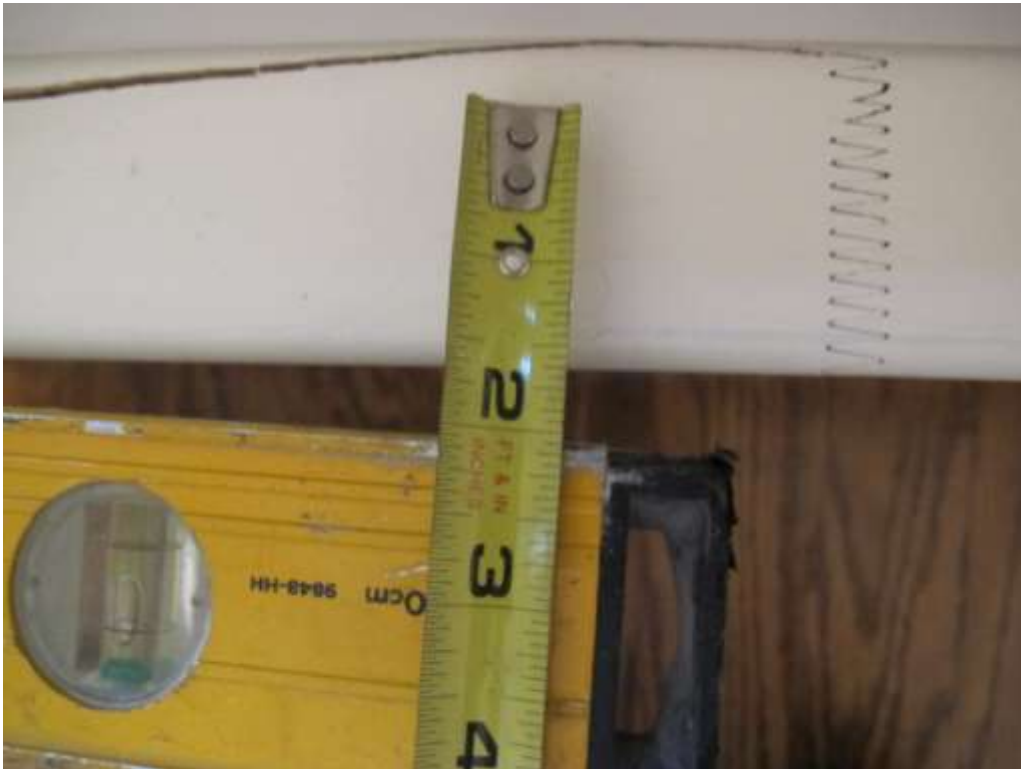
Photo 26: Close up of deflection in previous photo.
